CR-184003

Final Report for the M-52 Spray Booth Qualification Test

July 1990

Thiokol CORPORATION
SPACE OPERATIONS

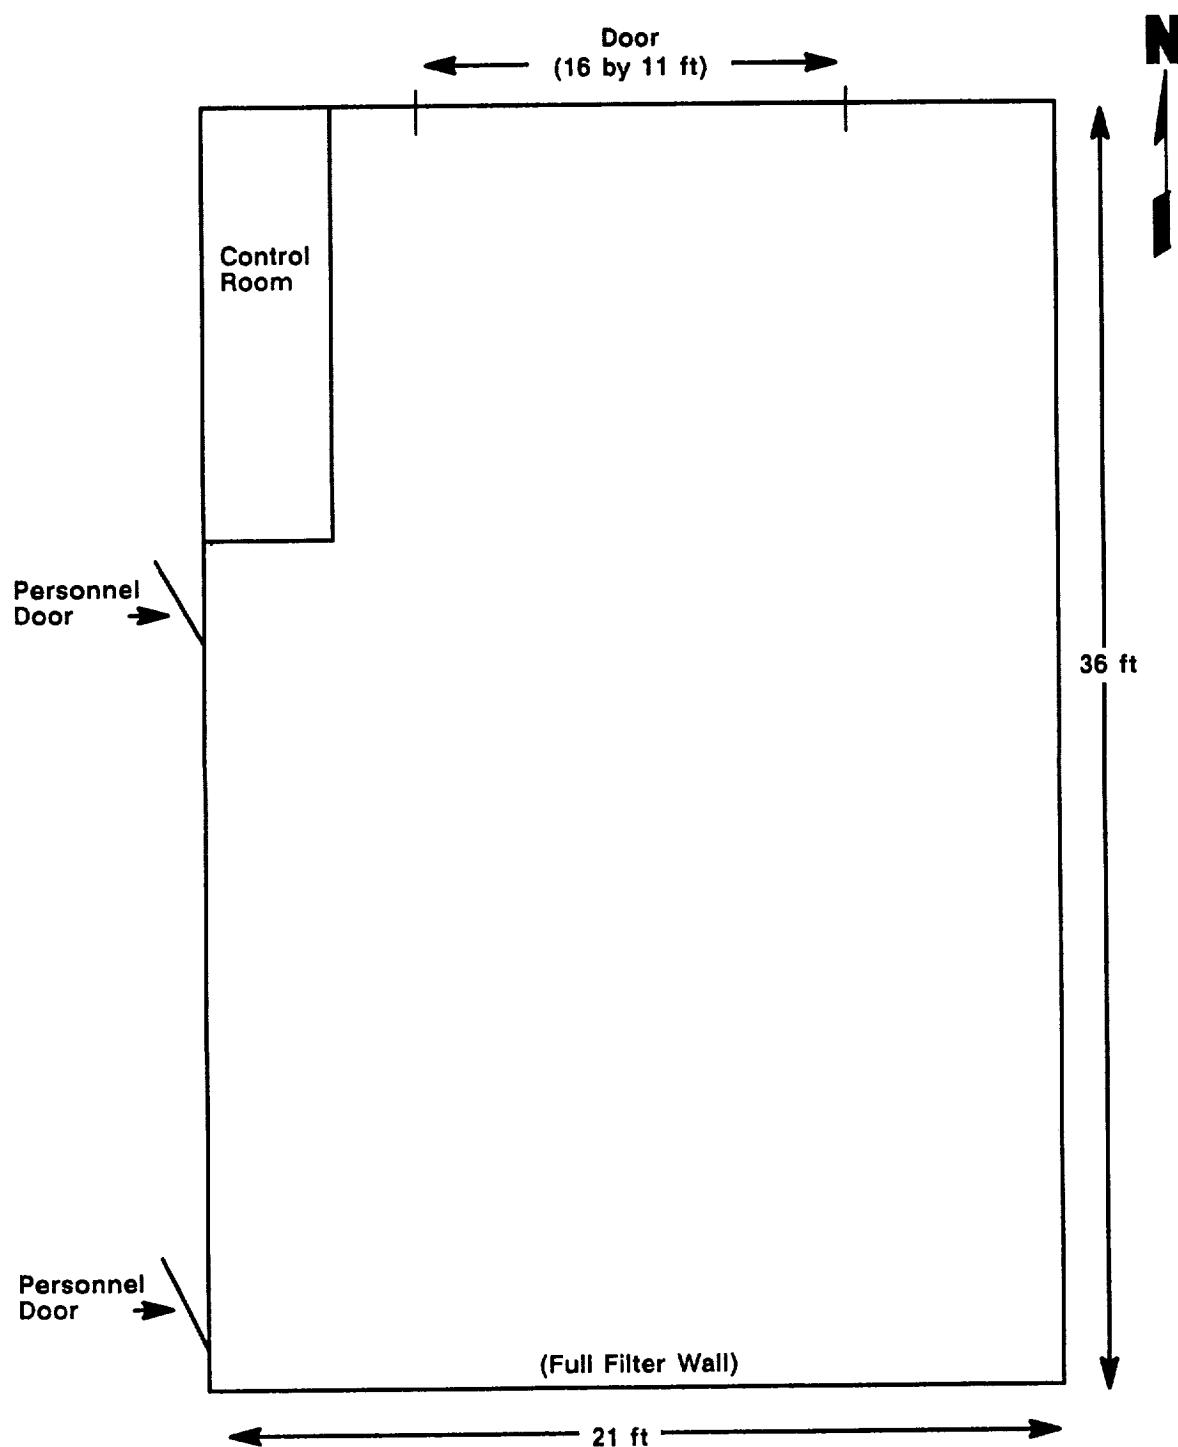
Figure 1. Spray Booth Configuration

The test article consisted of a stainless steel room, 21 ft wide by 36 ft long with an 11 ft high ceiling. The south wall provided a full wall filter vapor exhaust system. The floor had been encapsulated prior to testing. The spray booth had two doors on the west wall for personnel access, and one large door on the north wall used for items to be painted (Figure 1).

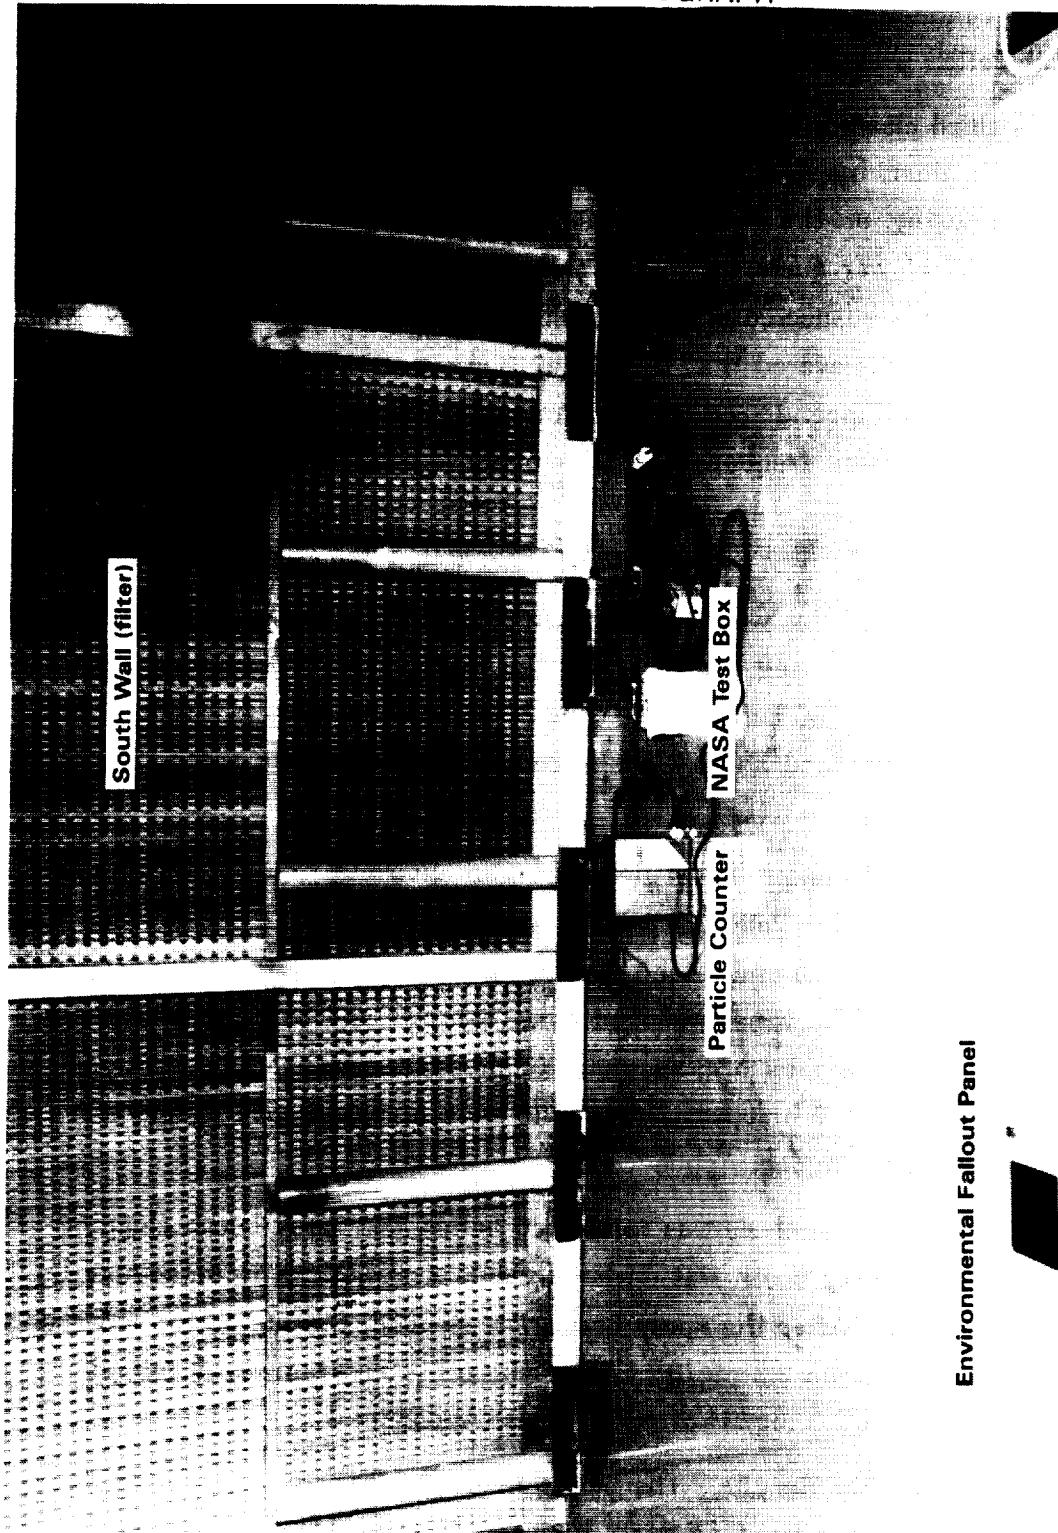
Figure 5. Contamination Removal Test Setup

operation per CTP-0142, Revision A. The particle counter uses lasers to count particulate in the air. It does not trap particulate in a filter. Therefore, no FTIR or NVR analysis were conducted on the particulate counts. Data from the first particle counter usage was lost. The average particulate count after the last spray booth cleaning was 14 particles (5μ or larger)/ft³ of air (Appendix J). The pass/fail criteria was established at less than or equal to 1,000 particles/ft³ for particles of 5μ or larger. The particulate count was well within the pass/fail criteria.

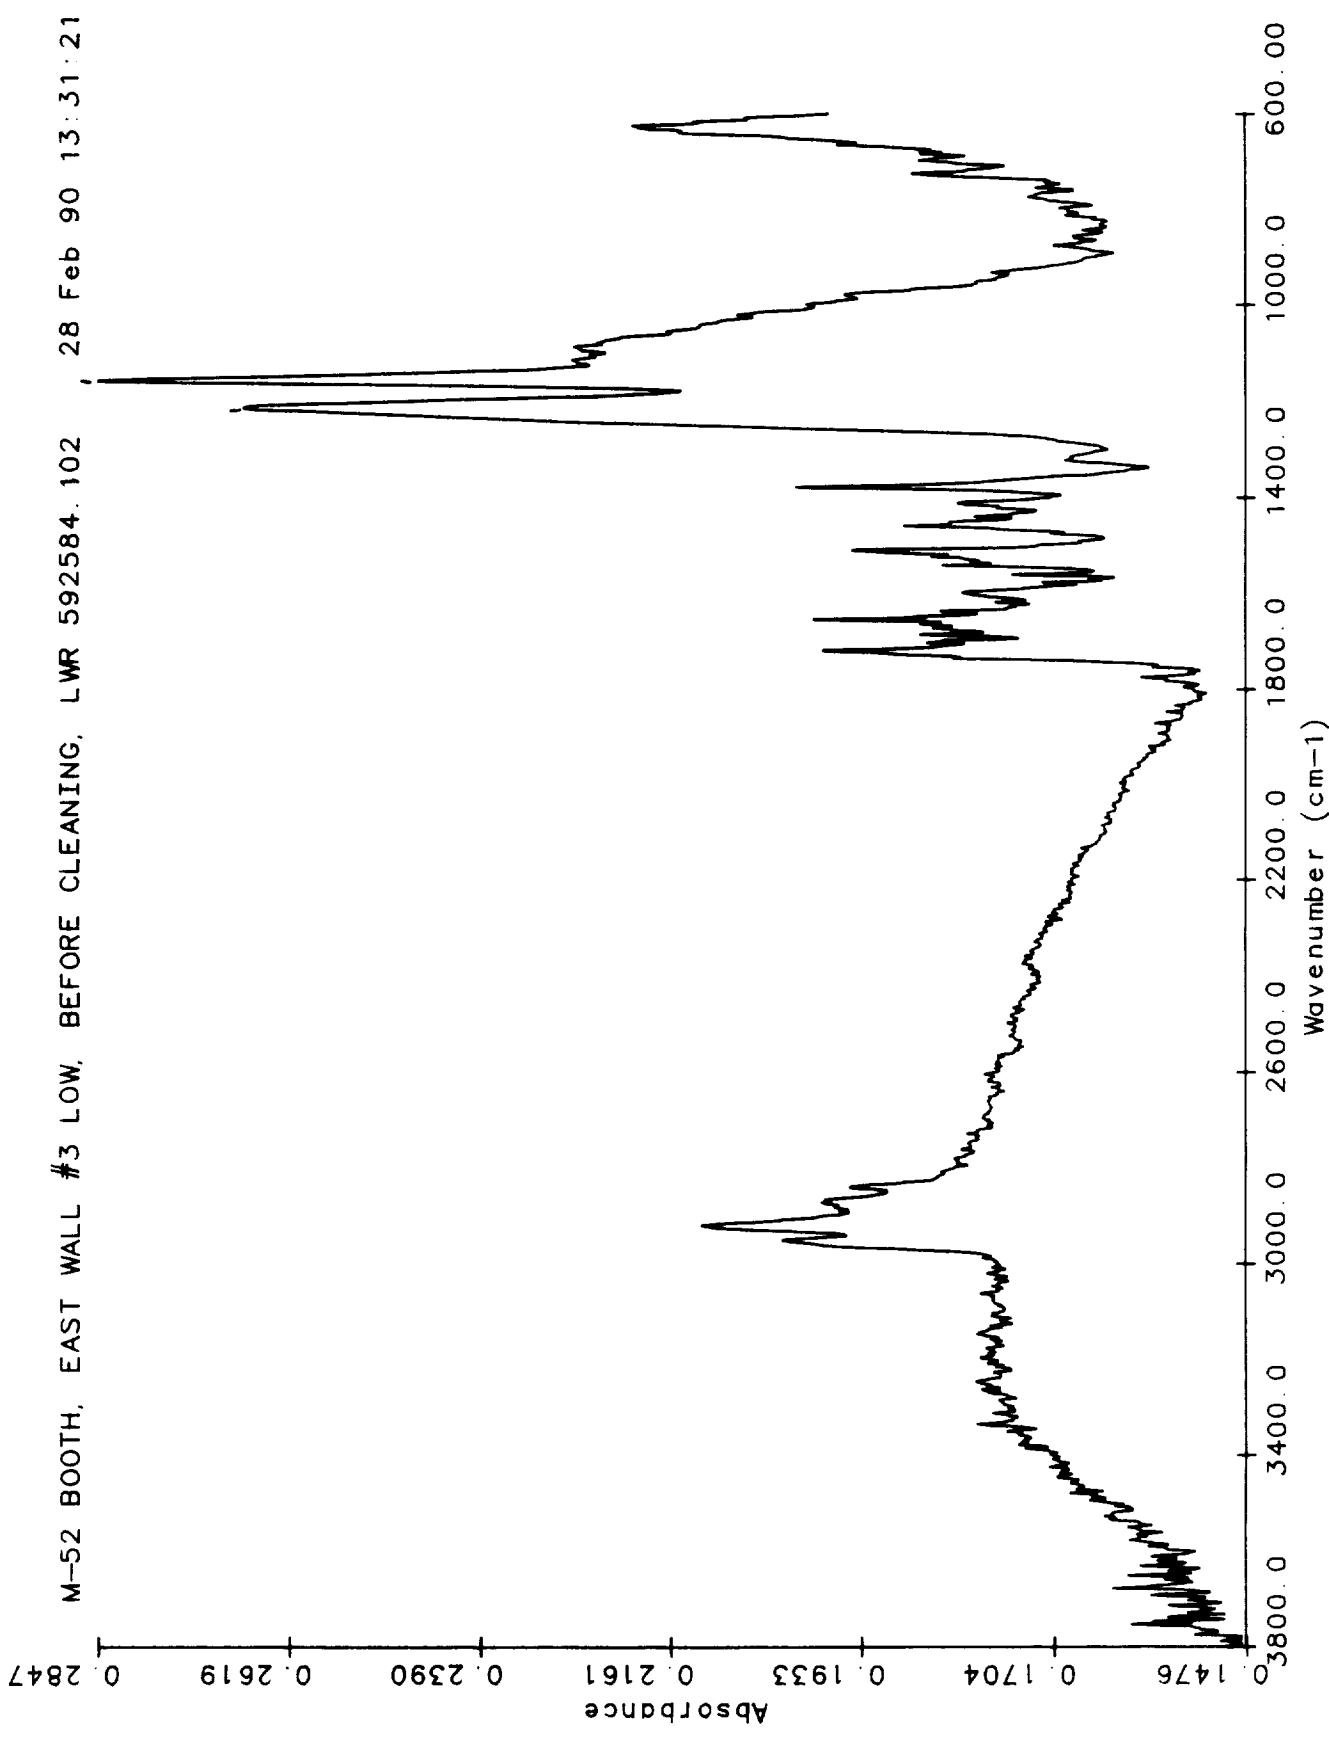
M-52 BOOTH, EAST WALL #3 LOW, BEFORE CLEANING, LWR 592584.102
28 Feb 90 13:31:21

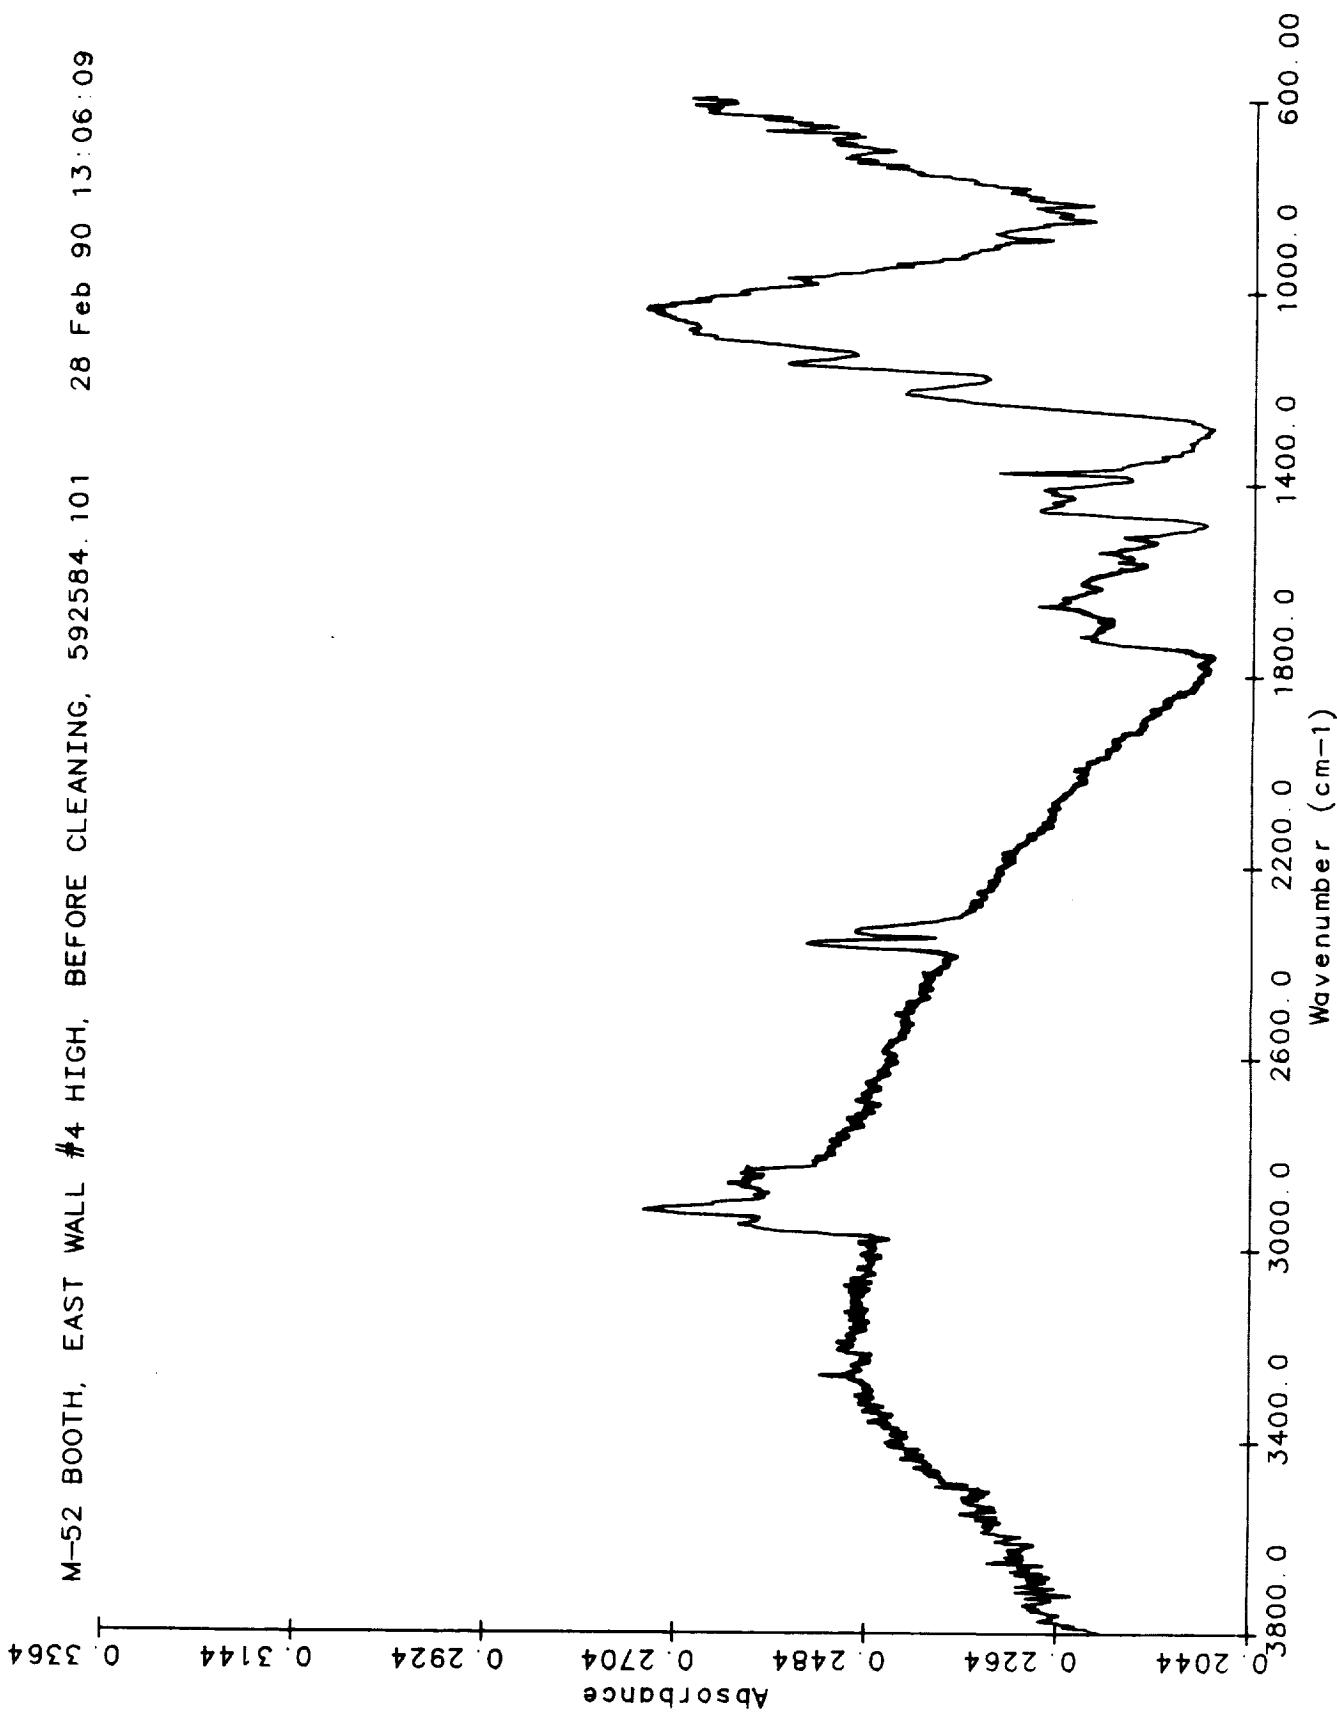
M-52 BOOTH, EAST WALL #4 HIGH, BEFORE CLEANING, 592584.101 28 Feb 90 13:06:09

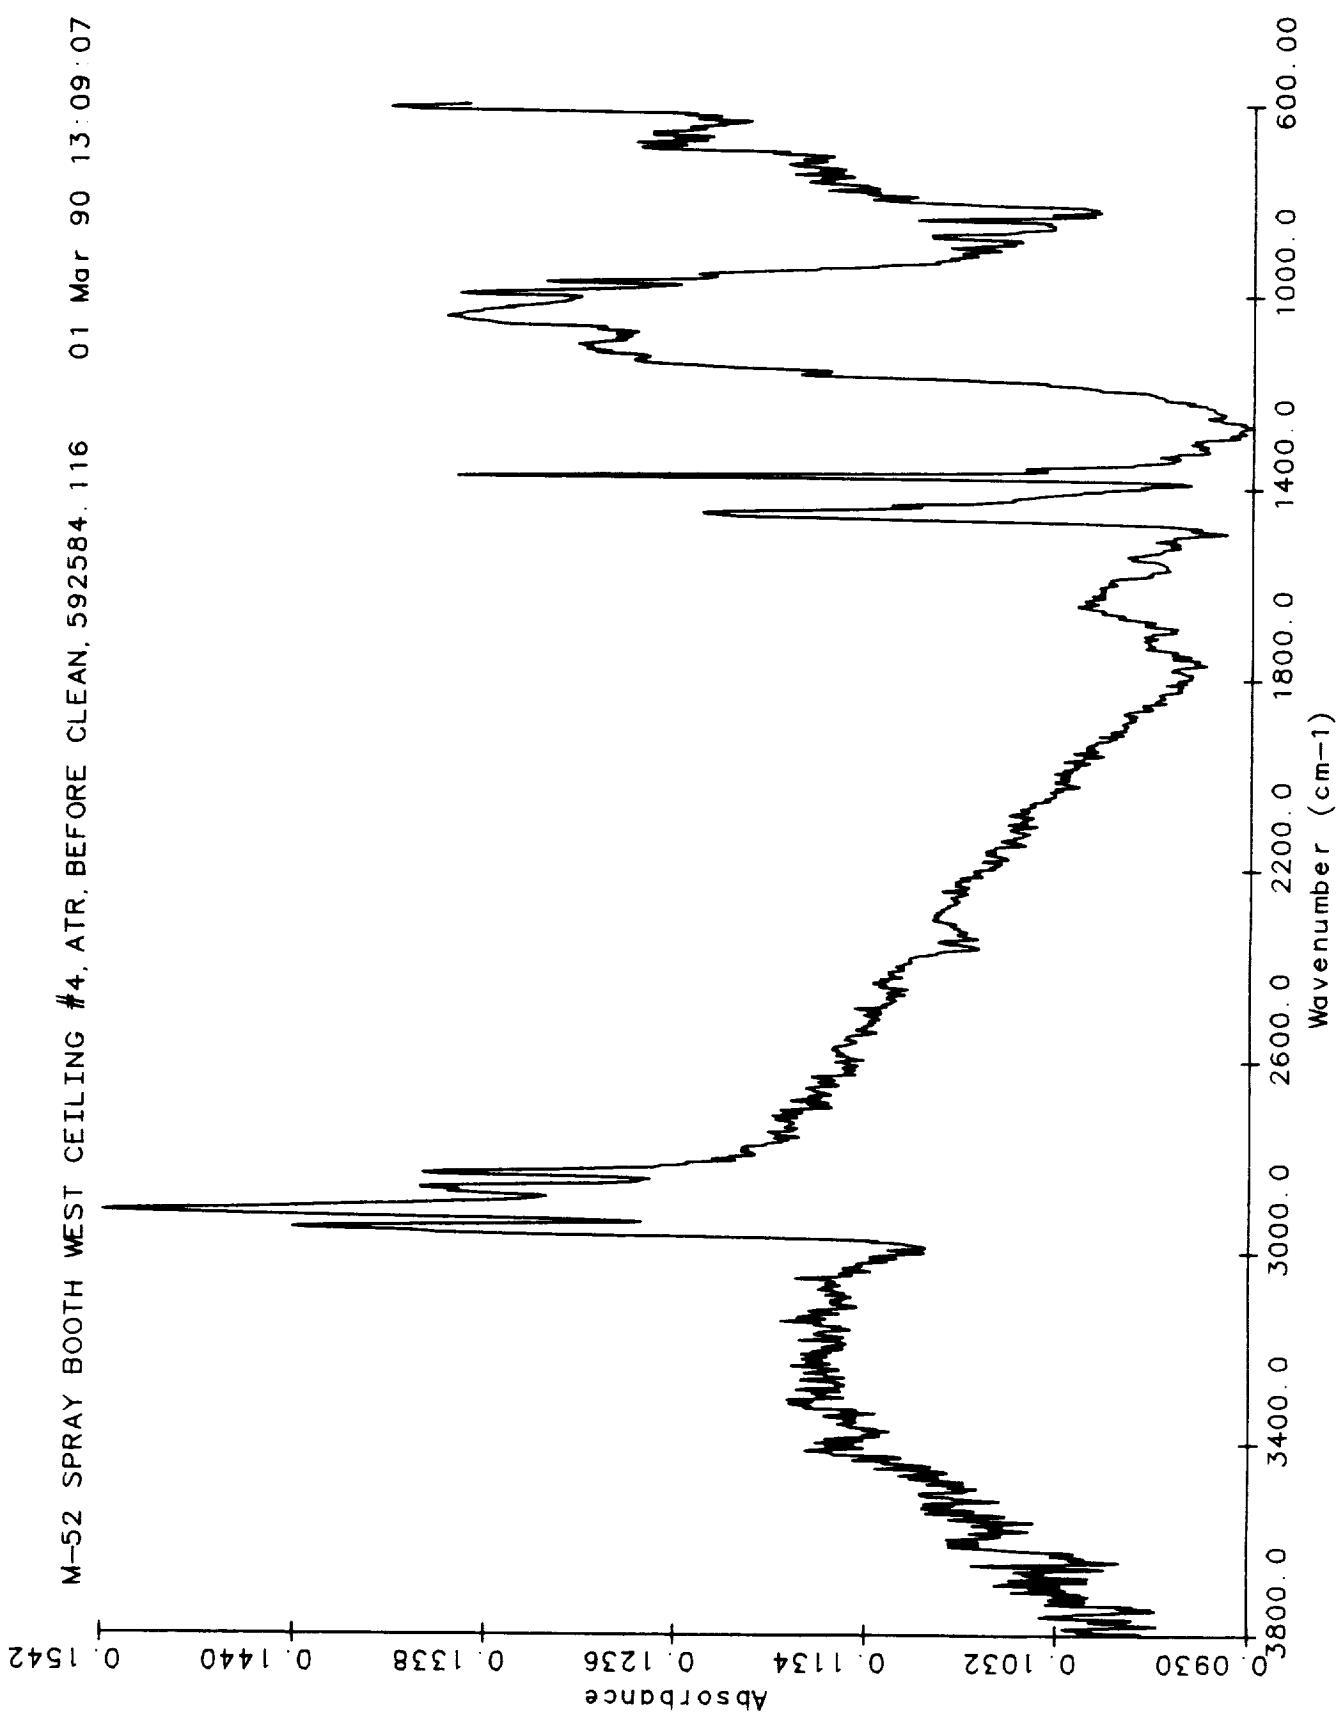
M-52 SPRAY BOOTH WEST CEILING #4, ATR, BEFORE CLEAN, 592584.116 01 Mar 90 13:09:07

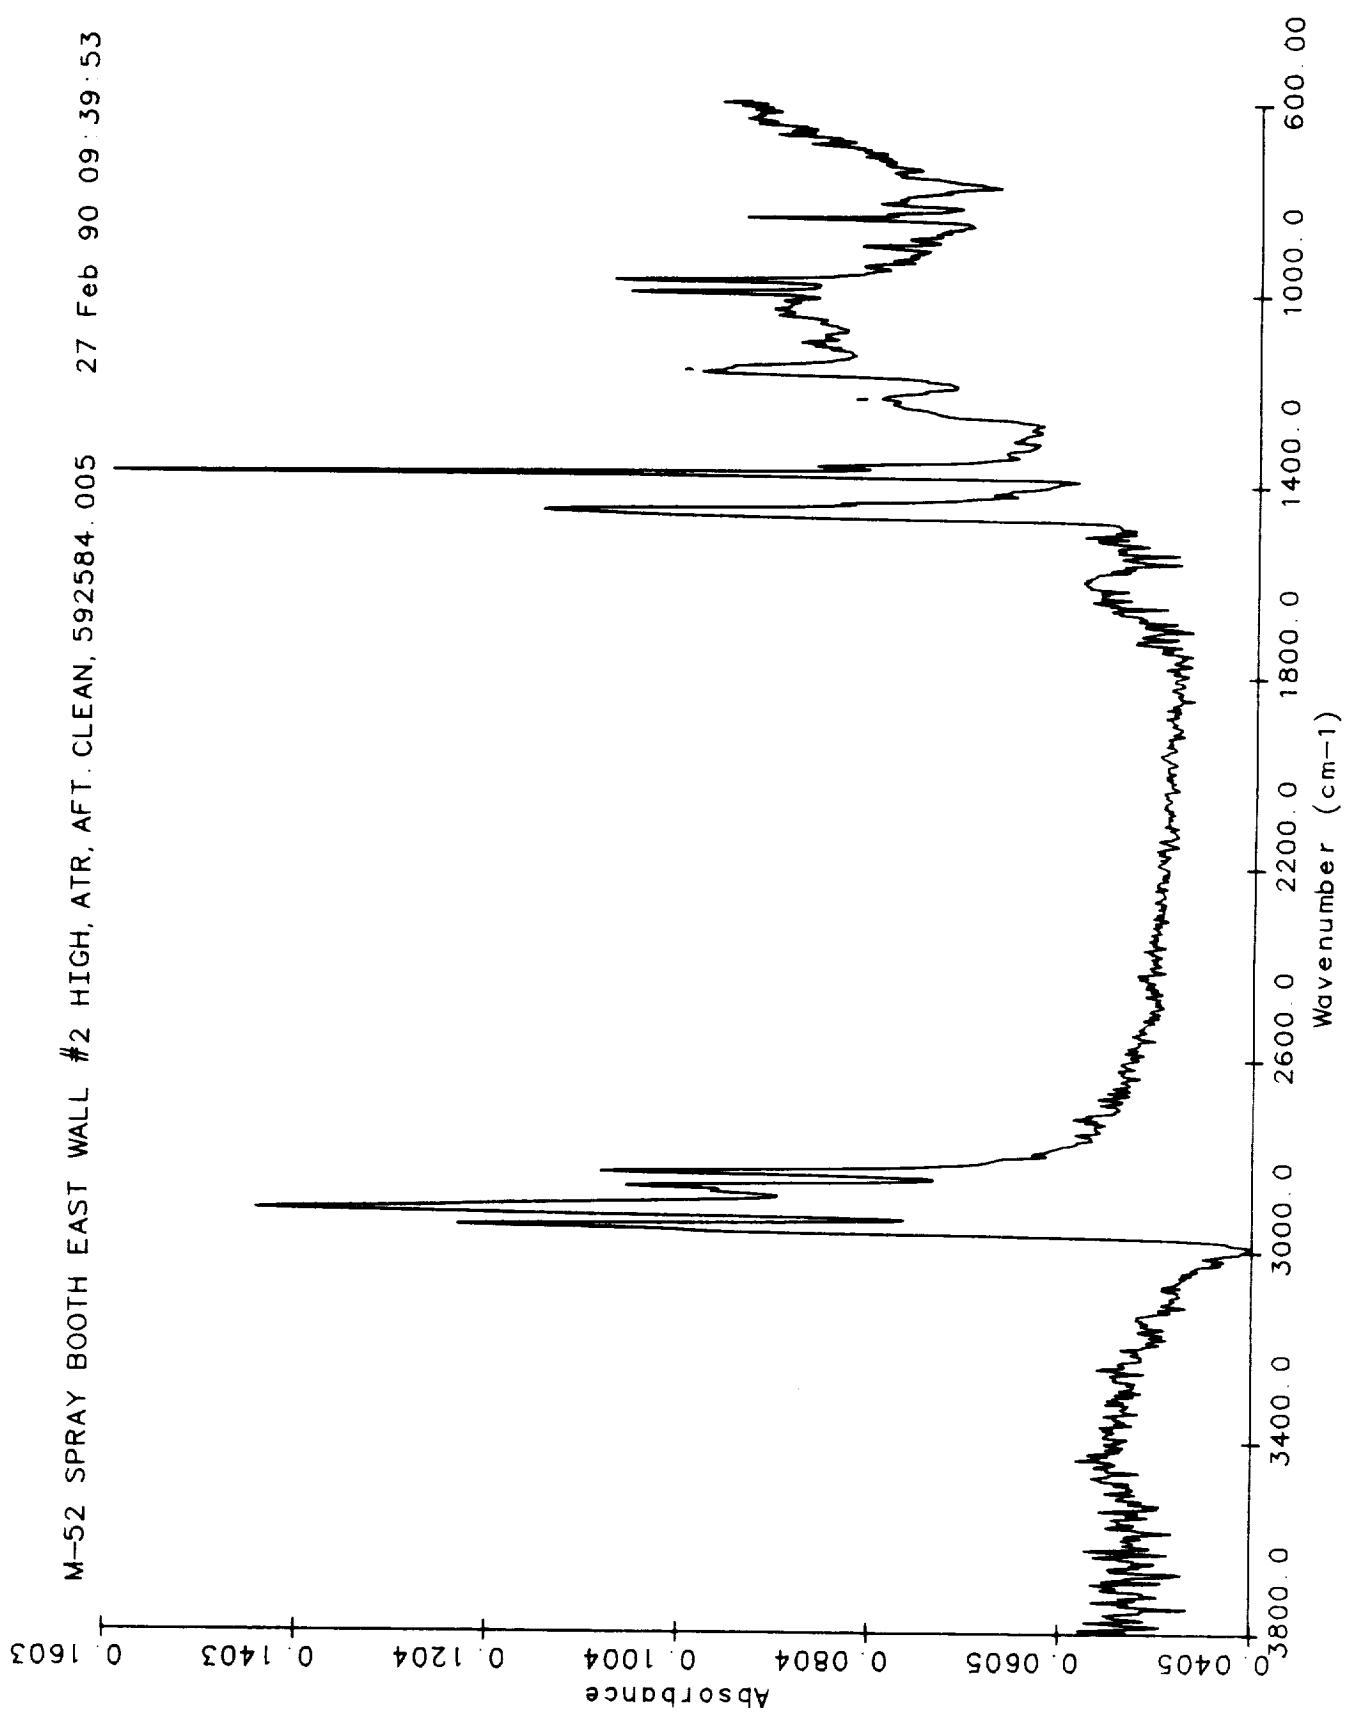
M-52 SPRAY BOOTH EAST WALL #2 HIGH, ATR, AFT. CLEAN, 592584.005

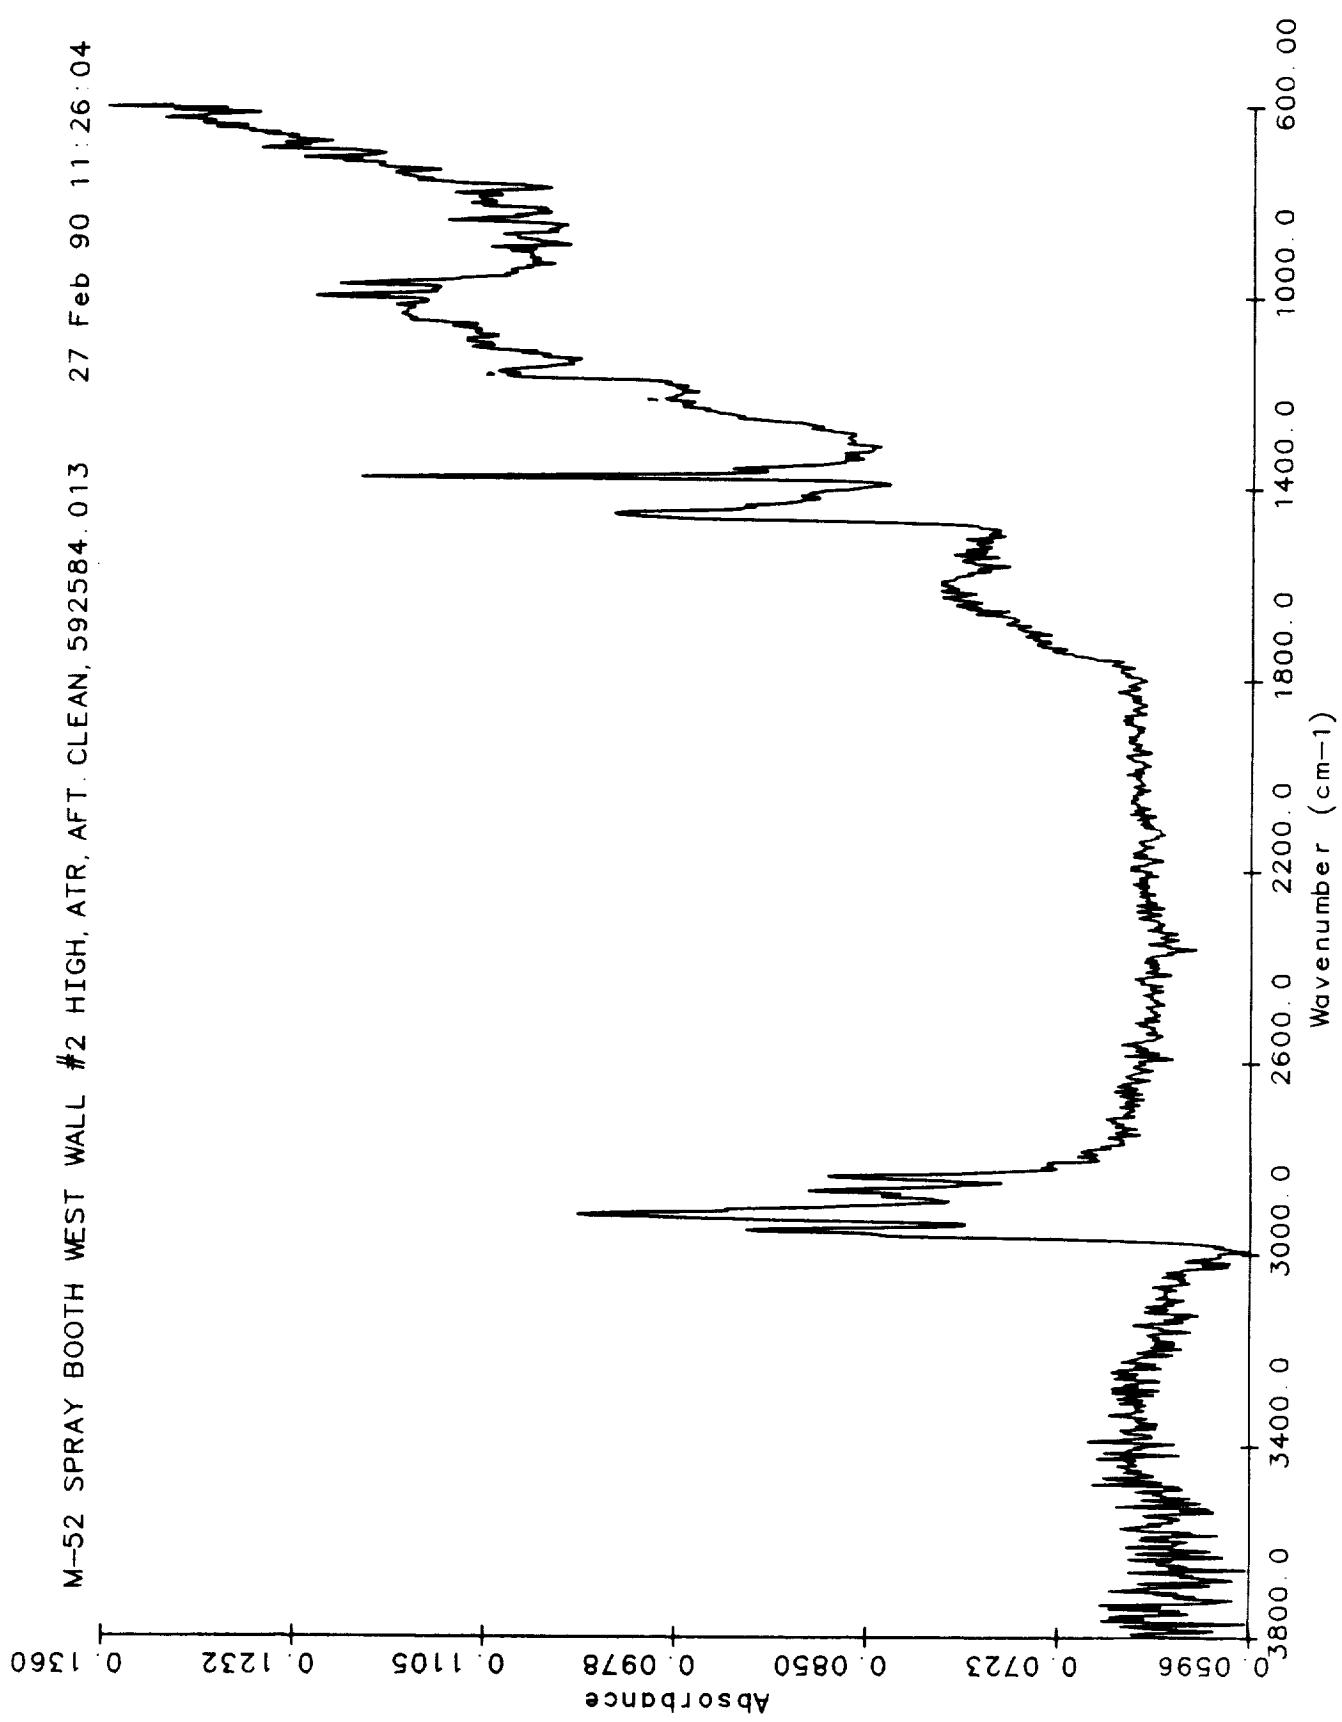
M-52 SPRAY BOOTH WEST WALL #2 HIGH, ATR, AFT, CLEAN, 592584.013 27 Feb 90 11:26:04

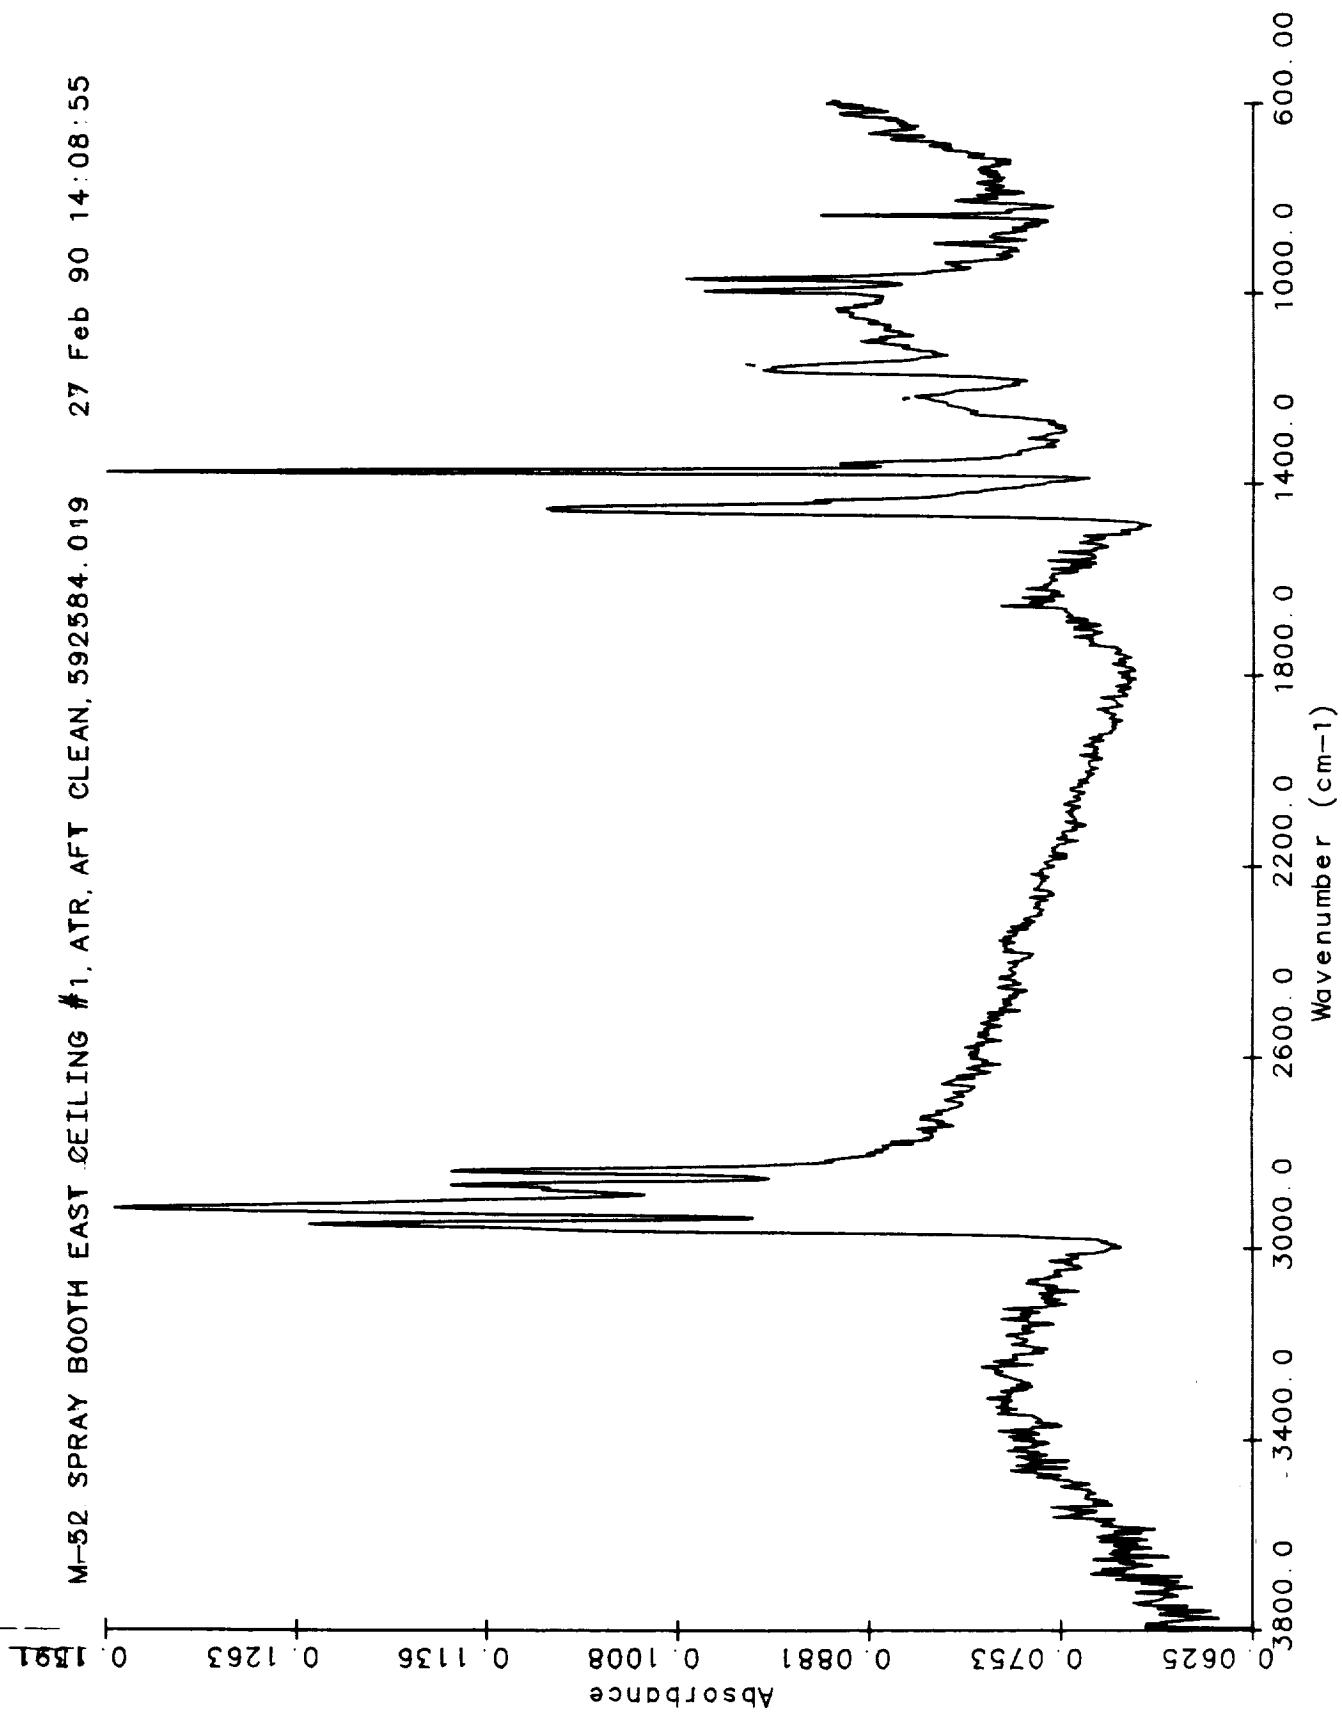
M-52 SPRAY BOOTH EAST CEILING #1, ATR, AFT CLEAN, 592584.019 27 Feb 90 14:08:55

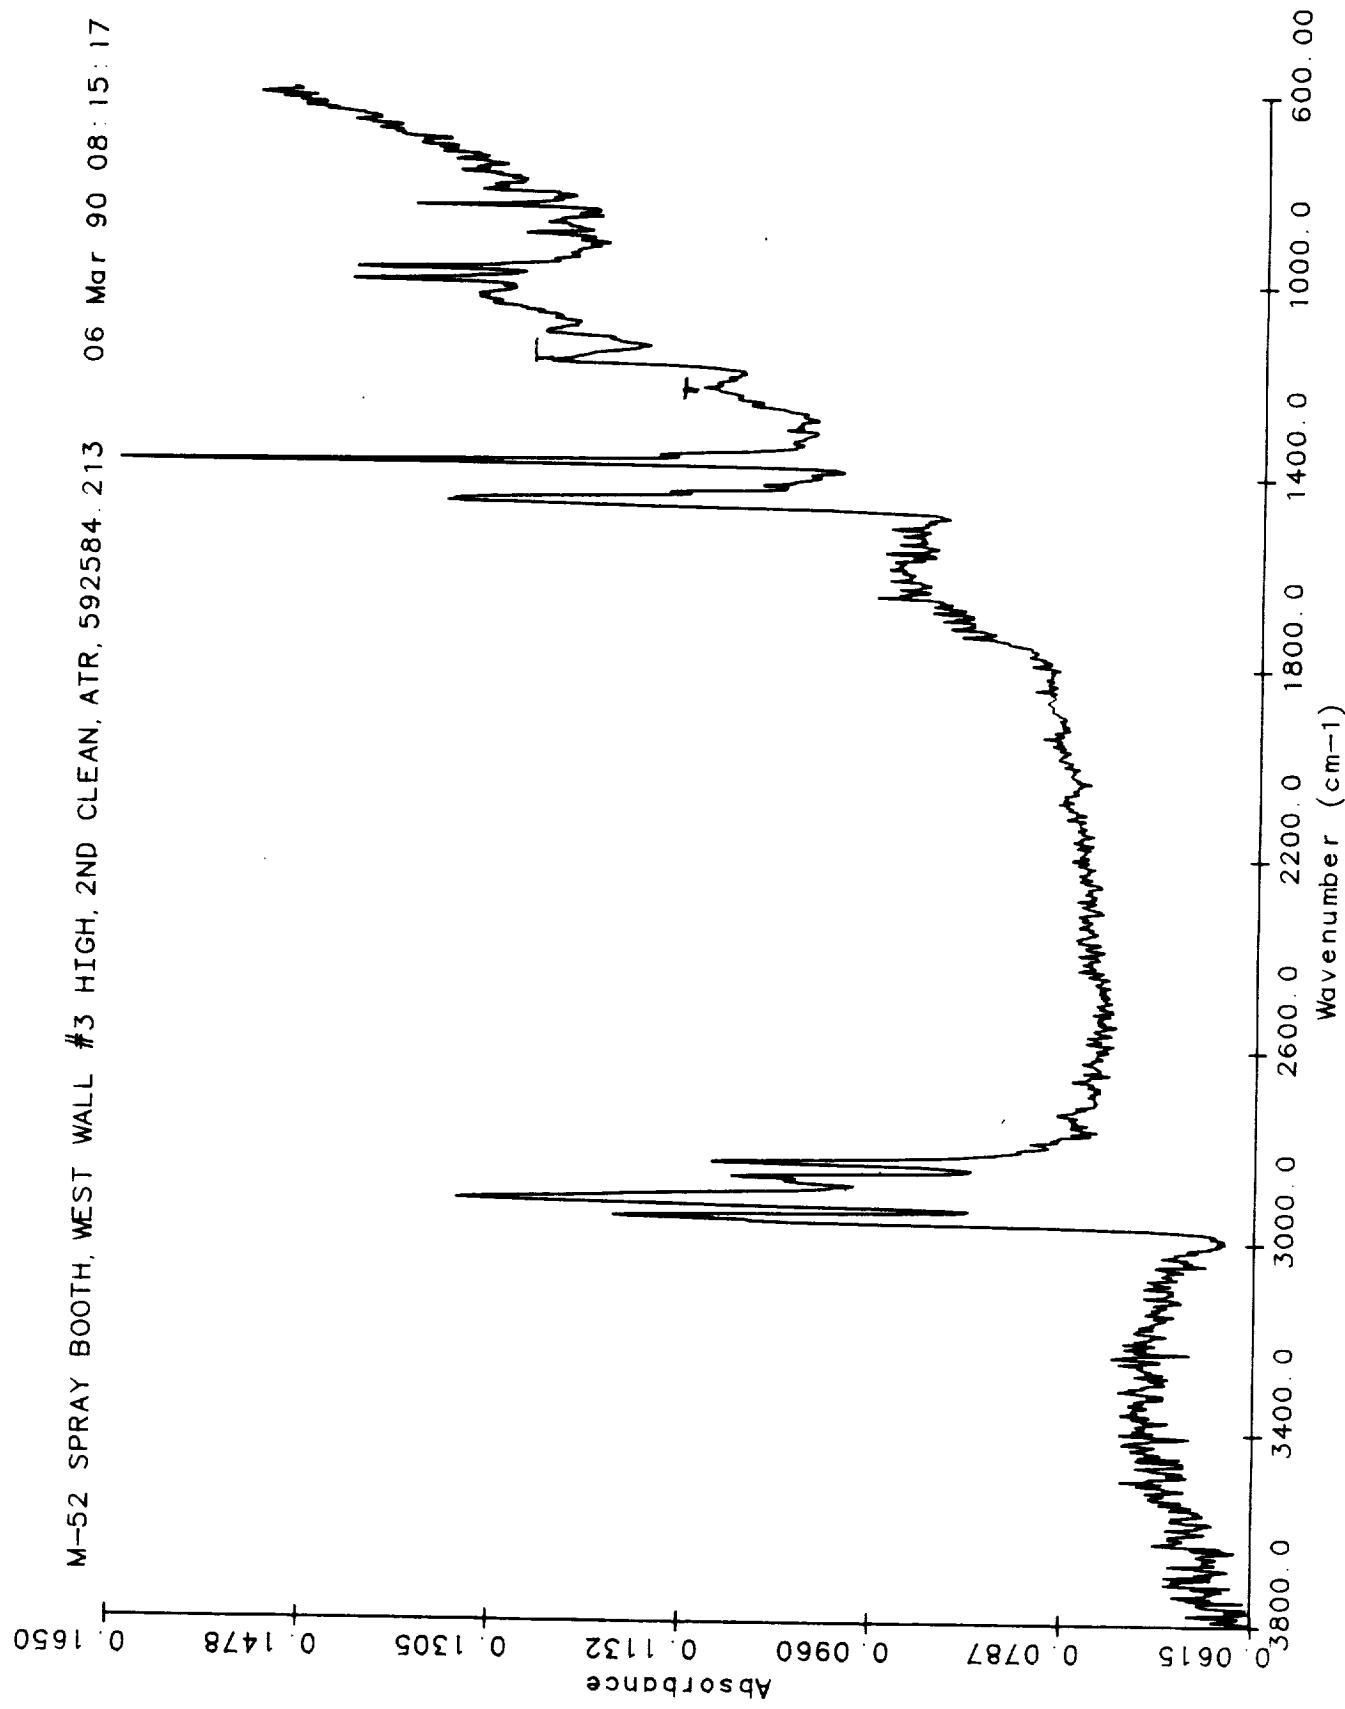
M-52 SPRAY BOOTH, WEST WALL #3 HIGH, 2ND CLEAN, ATR, 592584.213 06 Mar 90 08:15:17

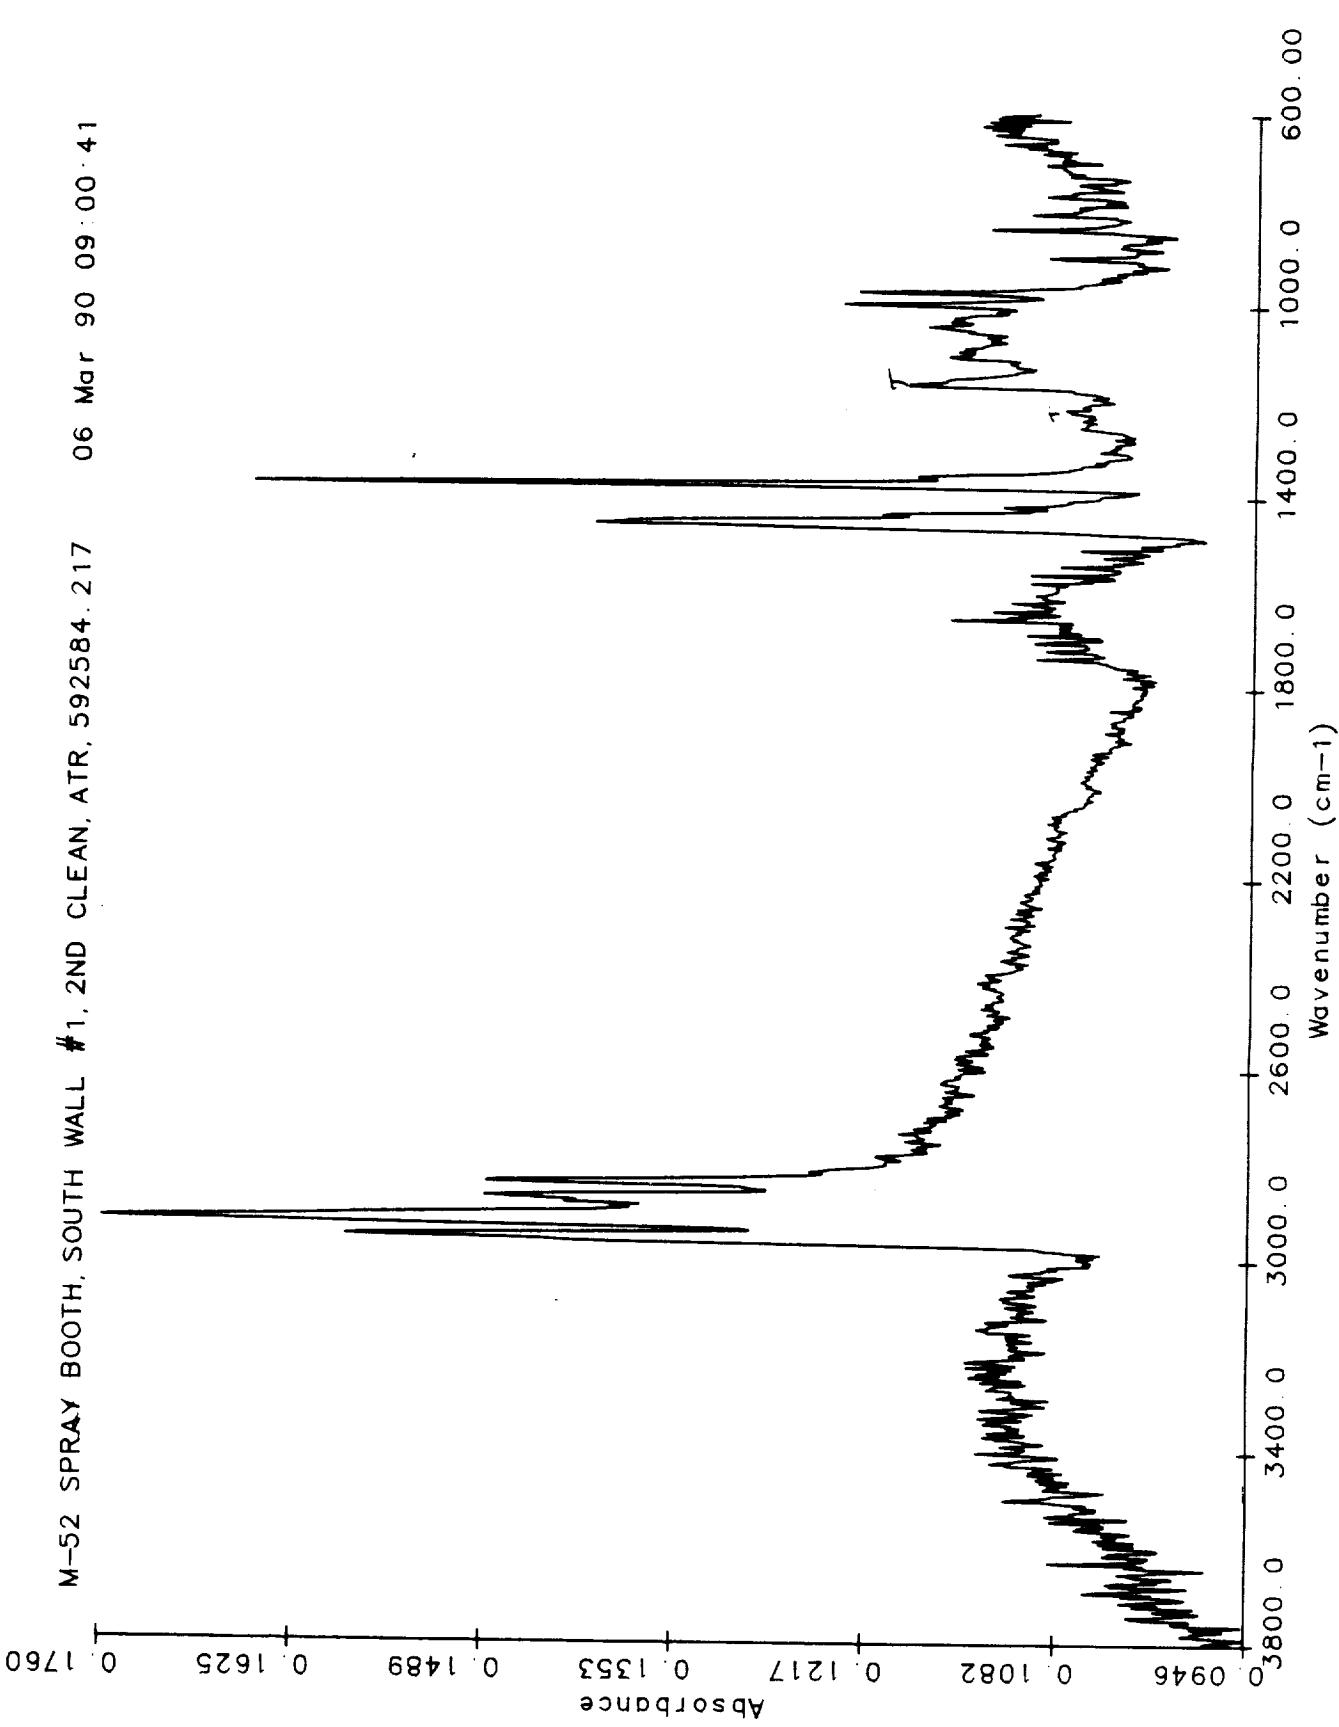
M-52 SPRAY BOOTH, SOUTH WALL #1, 2ND CLEAN, ATR, 592584.217 06 Mar 90 09:00:41
